**PHASE II ENVIRONMENTAL SITE ASSESSMENT REPORT  
for TARGETED BROWNFIELDS ASSESSMENT**

**AGENCY DUMP SITE**

**Fort Belknap Agency, Fort Belknap Indian Reservation, Montana**

**APRIL 22, 2004**

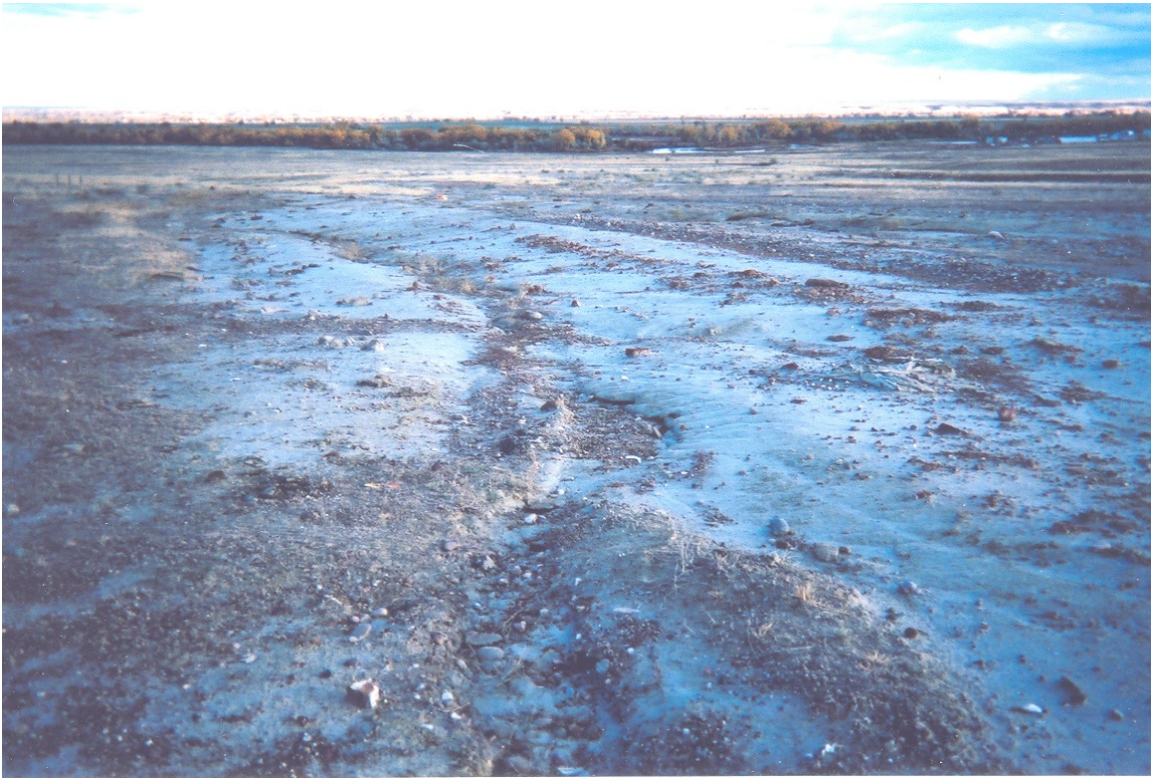
The Agency Dump site has been divided into several sections where waste potentially exists: a trench area (Photos 1 through 6), a debris area (Photos 7 through 9), and an auto salvage area. The trench area covers approximately seven acres and is poorly vegetated uneven terrain with a few sink holes present (Figure 2). It is difficult to visually distinguish individual trenches. The debris area is located in ravines to the southwest of the trench area where construction waste, drums, and vehicle parts were dumped. The debris area covers approximately 0.85 acres. The contents in the debris area have not been covered. Finally, an auto salvage area is present west of the debris area. The auto salvage area covers approximately 0.5 acres. During the original site reconnaissance, approximately 15 cars were stacked in this area. During field activities, the cars had been removed; however, broken glass and petroleum stains were visible.

**PHOTO 1**  
Agency Dump site, trench area.

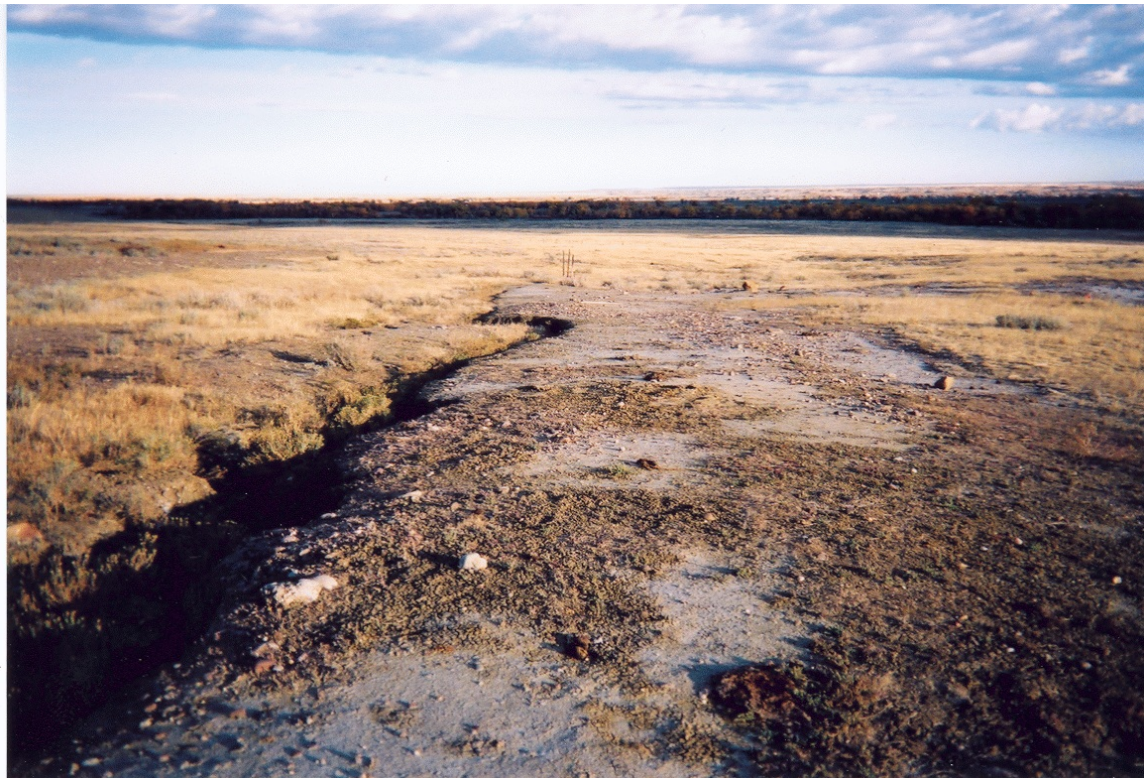
Surface drainage from the site flows to the north/northwest toward the Milk River. A portion of the drainage area has been covered with fill and is a possible trench that was used for waste disposal. The fill has been eroded by water flow and has several large depressions and gullies forming (Photos 2 and 6). Waste is not visible in the depressions.

**PHOTO 2**  
Drainage channel from the trench area.

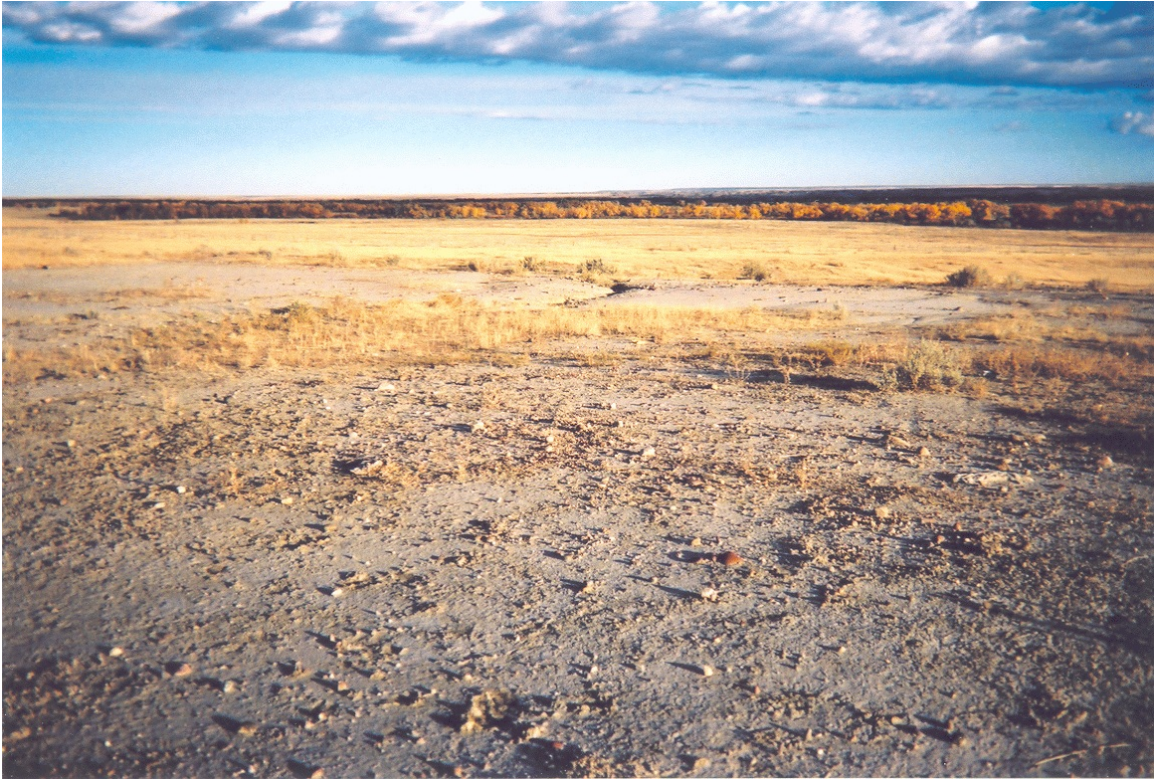
**PHOTO 3**  
Agency Dump site, trench area.

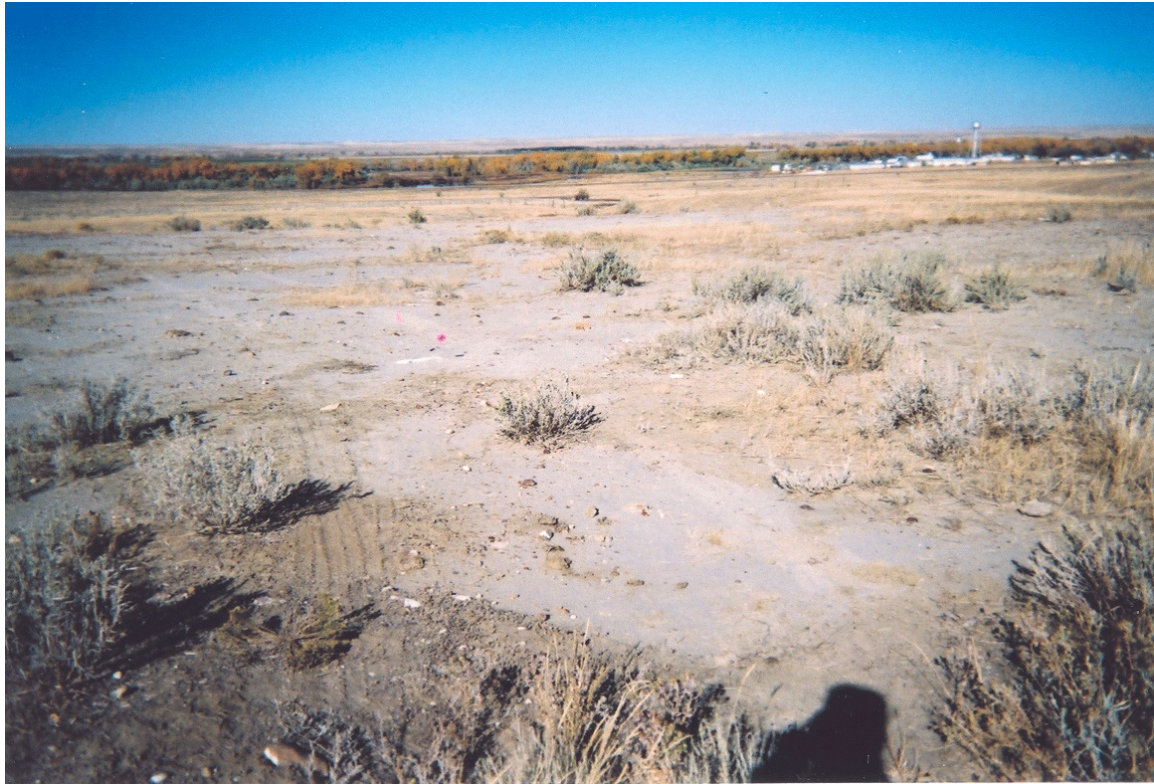
**PHOTO 4**  
Agency Dump site, trench area.

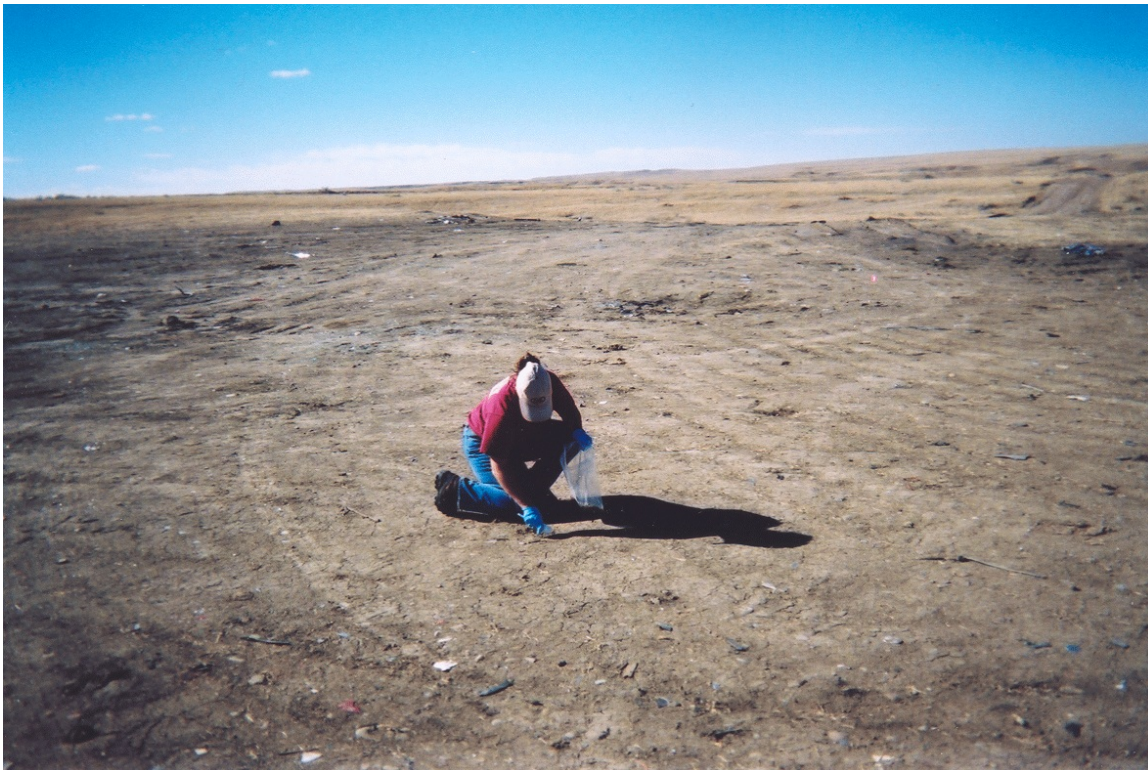
**PHOTO 5**  
Collecting Samples from the trench area.

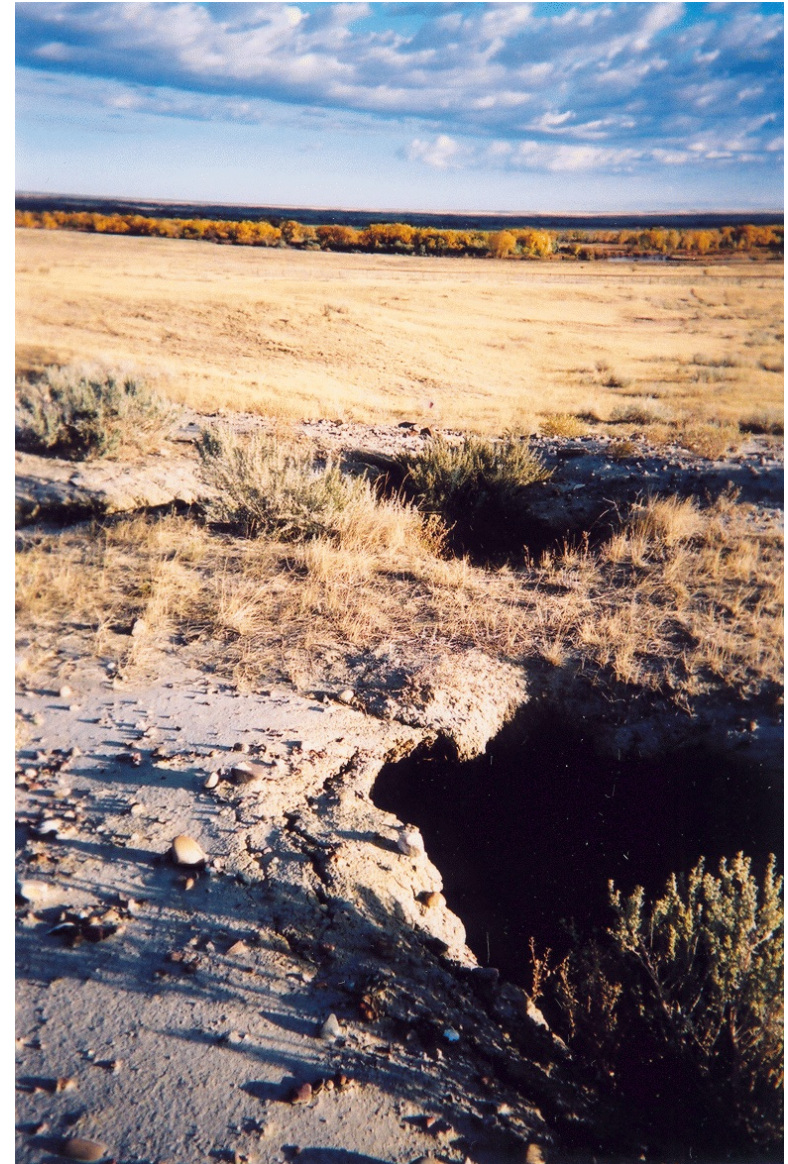
**PHOTO 6**  
Agency Dump site, sink hole in the trench area.r

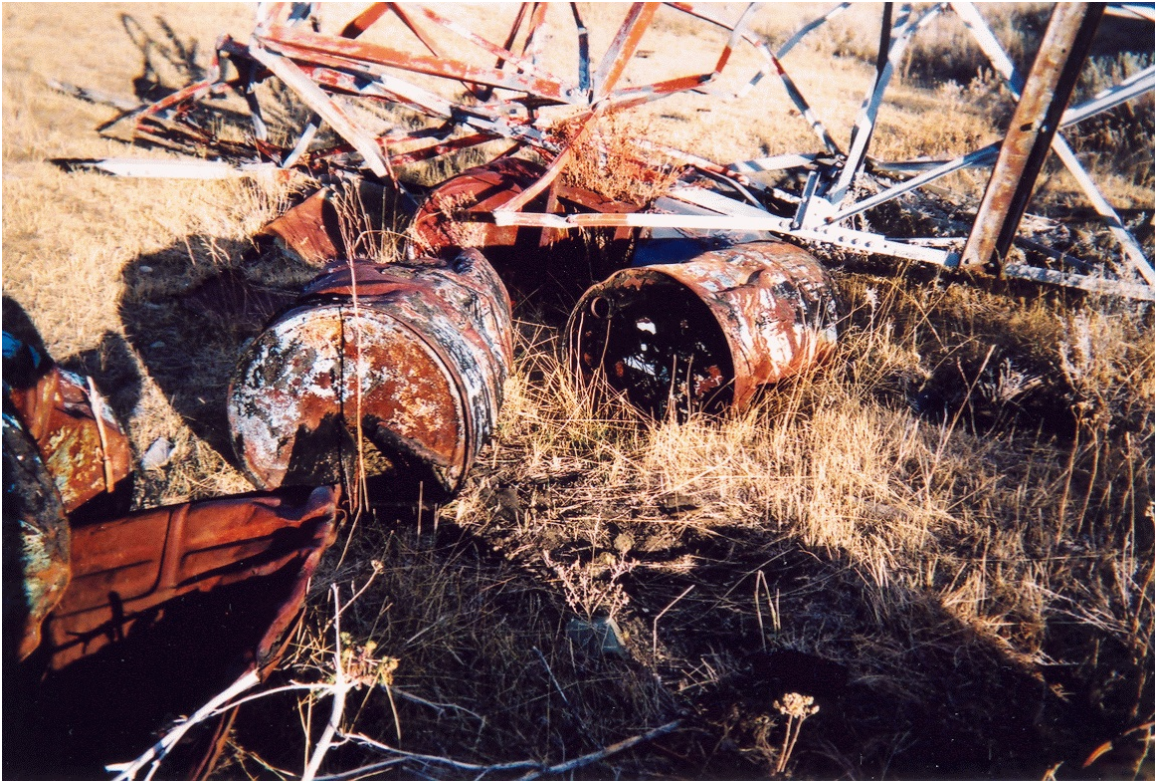
**PHOTO 7**  
Surficial debris in the debris area.

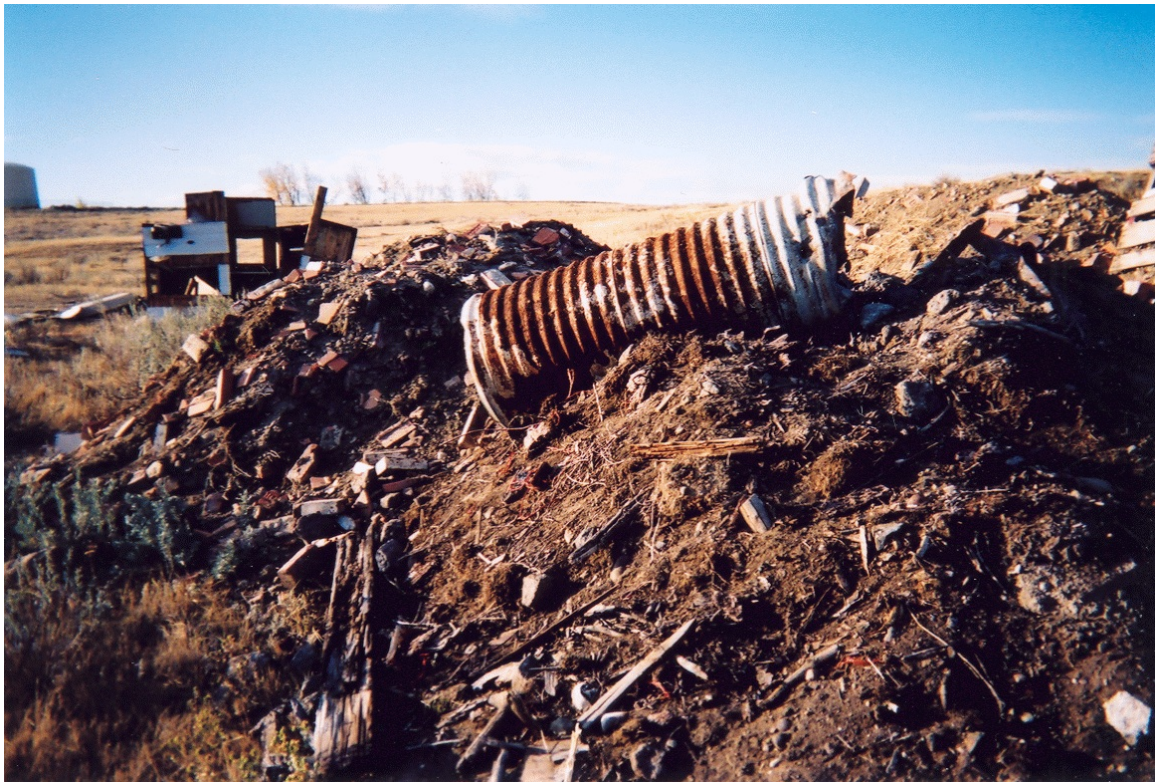
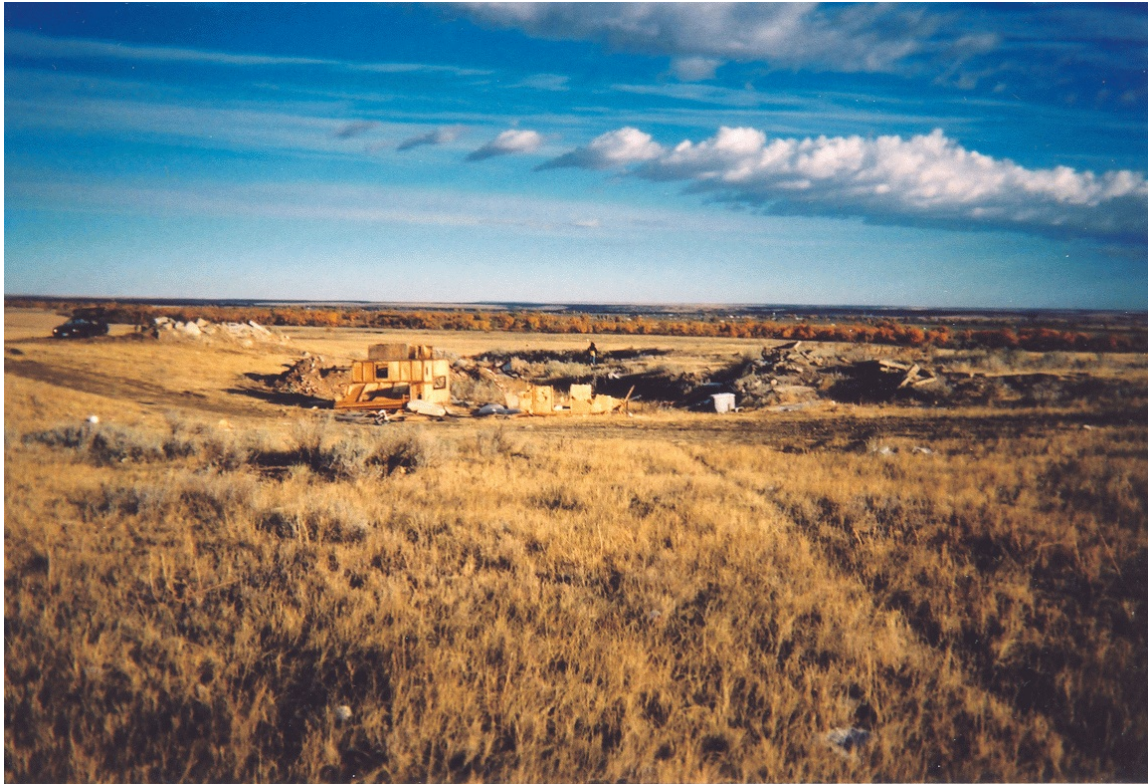
Two composite surface samples (AD-SO-DB-01 and AD-SO-DB-02) were collected from the debris area, west of the trench area. The debris area is geographically divided by a dirt road. The area south of the road contains waste that is generally metal and concrete. The area north of the road

contains 55-gallon drums and general trash. A five-point composite sample was collected from each of these areas to determine if contaminants were present. A grab surface soil sample (AD-SO-OP-01) was also collected from the debris area. This sample was collected from soil under a leaking 55-gallon drum. The soil under the drum was stained with a dark oily substance.

Samples AD-SO-DB-02 and AD-SO-OP-01 were collected in the northern half of the debris area. Both samples had concentrations of DEHP above the industrial RBC. Sample AD-SO-DB-02 also had concentrations of chrysene above the industrial RBC and concentrations of DDE and DDT above the residential RBCs. Samples from the debris area also had concentrations of arsenic and vanadium that are above the RBCs but are within the normal range of concentrations for soil in the western United States and are not three times above the background sample concentrations associated with sample AD-SO-BK-01(USGS 1984).

**PHOTO 8**  
Sample location AD-SO-DB-02.

**PHOTO 9**  
Sample location AD-SO-DB-02.

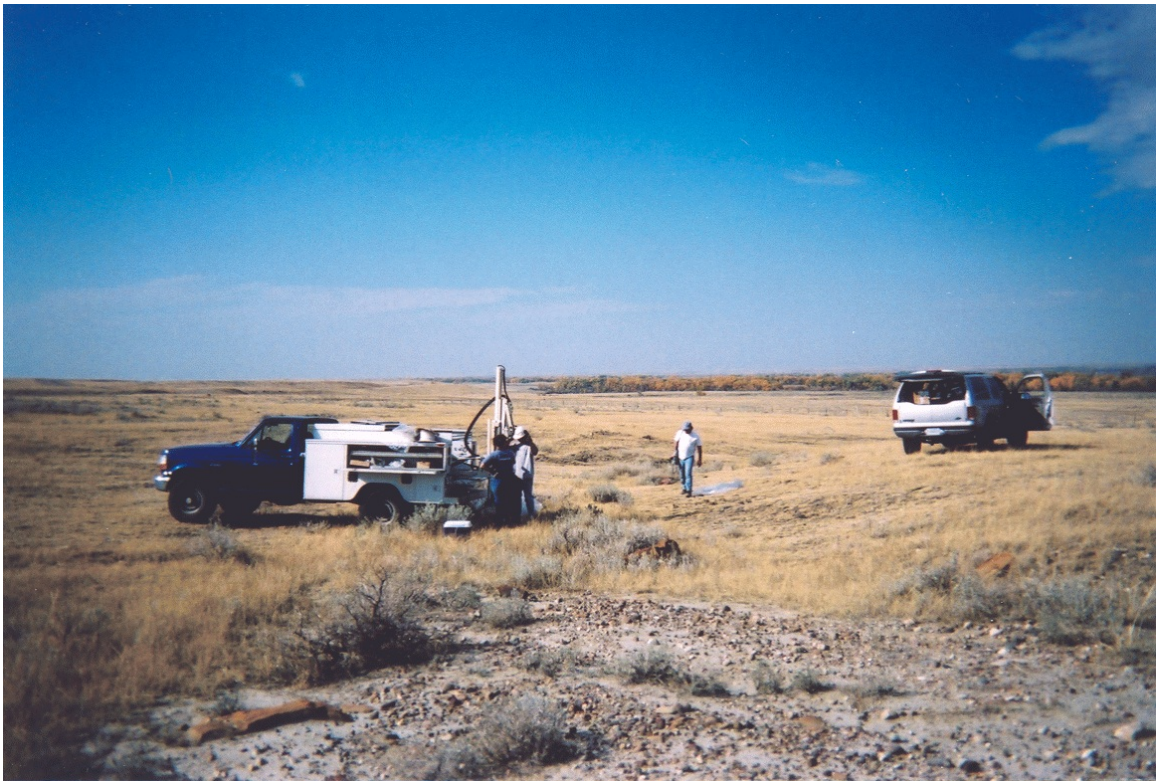
Three Geoprobe® boreholes were completed downgradient (north) of the trench area (Photo 11). Specifically, each borehole was completed within a drainage channel leaving the site. A subsurface soil sample was collected from each borehole. The depth of each soil sample is reported in Tables 2a and 3a. Groundwater was not encountered in the boreholes and therefore groundwater samples were not collected. An additional borehole was completed within one of the drainage areas; however, groundwater was not found at this location either. A total of six sediment samples were collected from the site. Sediment samples were collected from the drainage channels leaving the site and from low areas on site that potentially contain surface water runoff during high flow. Because surface water was not encountered on site, samples were only collected from the sediment matrix. One sediment sample was moist and was therefore analyzed for volatile organic compounds (VOCs).

**PHOTO 11**  
Geoprobe® activities.

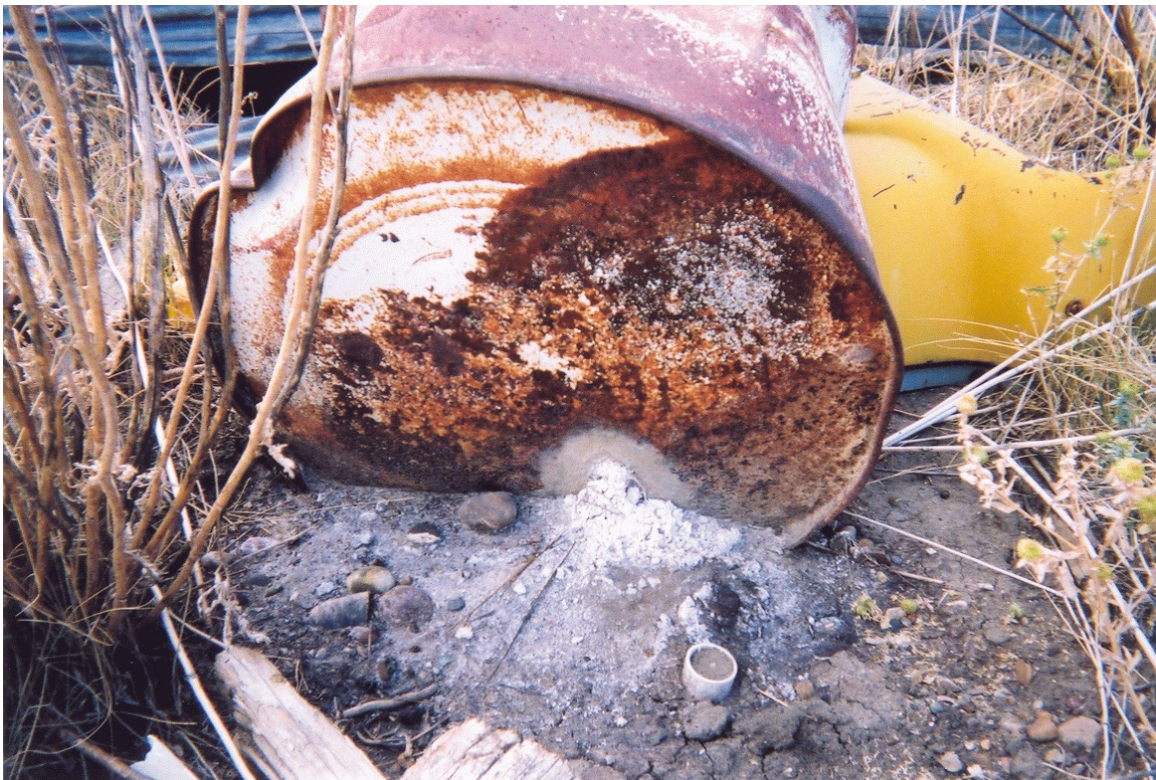
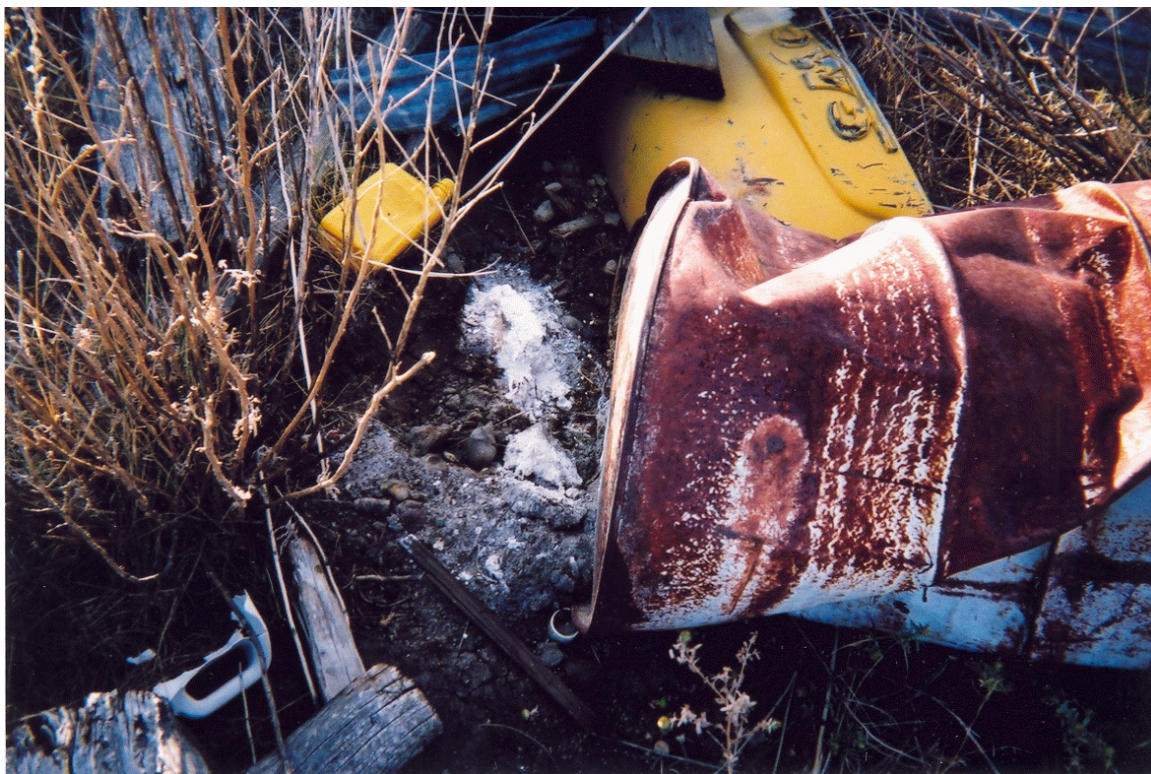
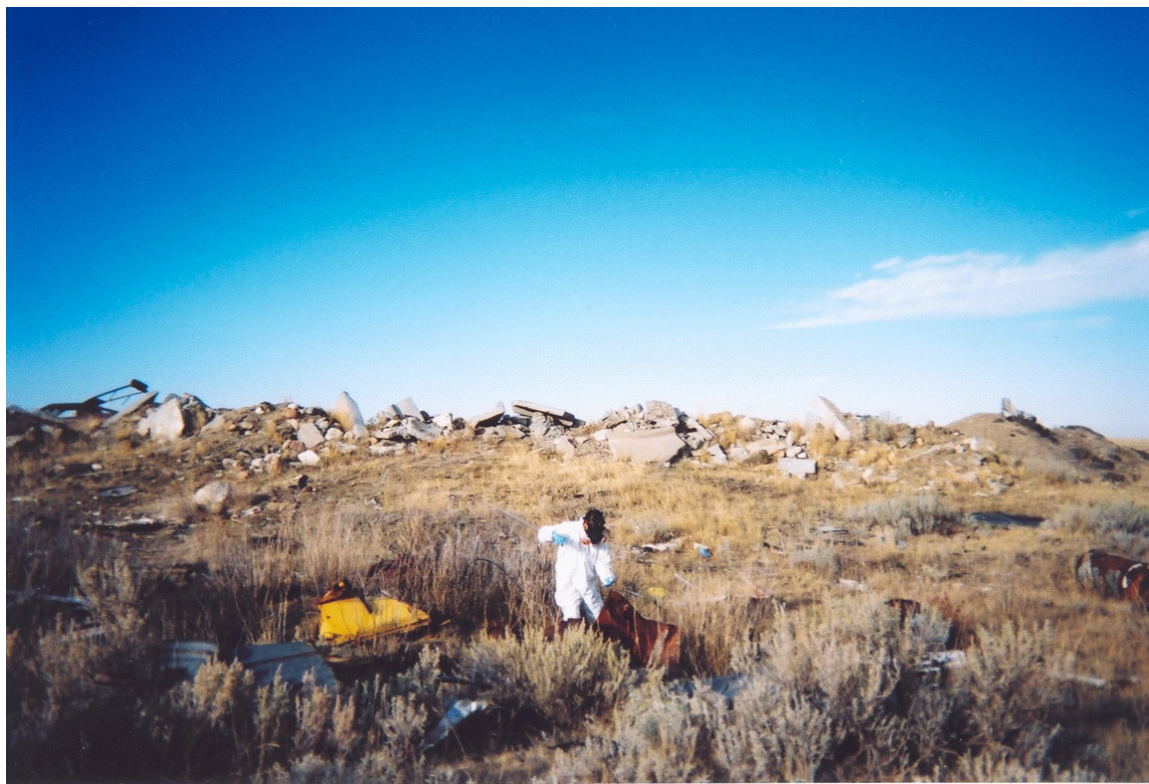
One sample was collected from a drum with unknown contents (Photos 12 through 14). The sample was field analyzed using a hazardous classification kit. In addition, the sample was sent to the laboratory for VOC, SVOC, pesticide/PCB, and TAL total metals analyses. The drum was open to the environment and the contents consisted of a fine white powder. One asbestos sample was collected from a pile of roofing material observed in the debris area (Photo 15). The roofing material was partially covered; however, asbestos-like fibers were visible.

One sample (AD-SS-DM-01) was collected from a drum with unknown contents. The sample was field analyzed using a hazardous classification kit. In addition, the sample was sent to the laboratory for VOC, SVOC, pesticide/PCB, and TAL total metals analysis. The drum was open to the environment and the contents consisted of a fine white powder. Based on the hazardous classification and analytical results the drum is thought to contain sodium carbonate.

**PHOTO 12**  
Sample location AD-SS-DM-01.

**PHOTO 13**  
Sample location AD-SS-DM-01.

**PHOTO 14**  
START2 collecting sample AD-SS-DM-01.

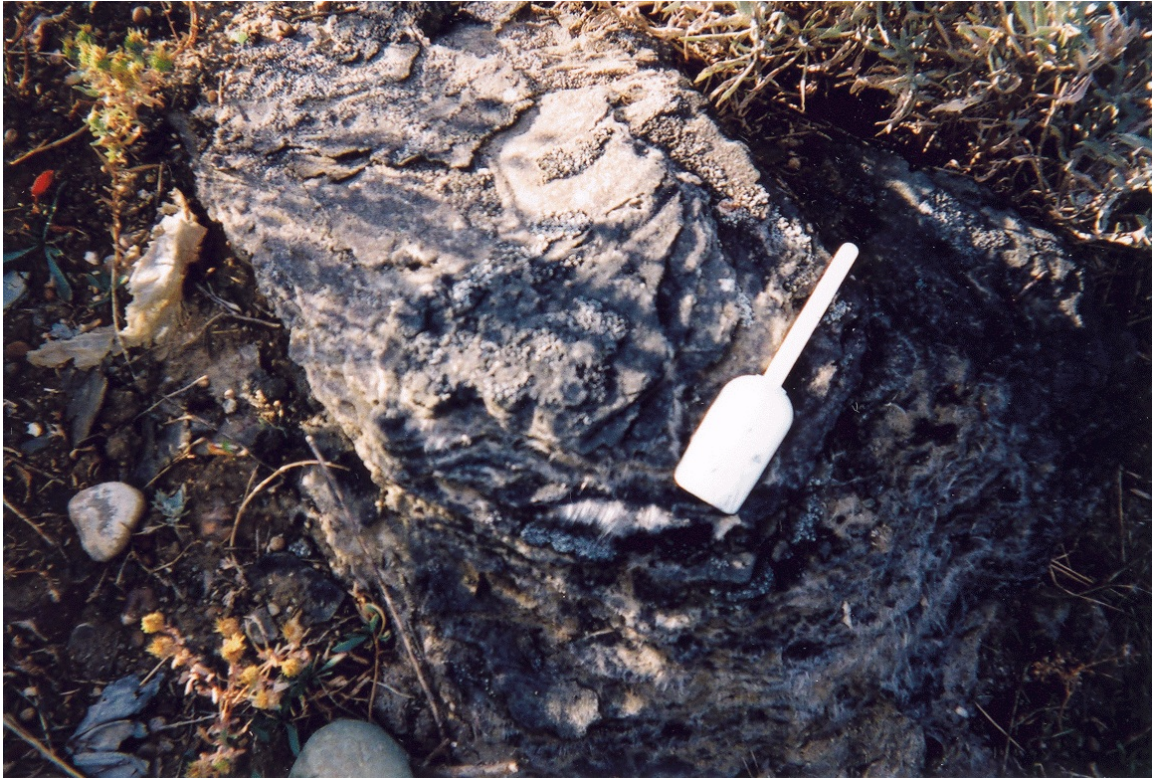
One asbestos sample (AD-SS-AS-01) was collected from a pile of roofing material observed in the debris area. The roofing material was partially covered; however, asbestos-like fibers were visible. The sample results indicated no asbestos fibers present.

**PHOTO 15**  
Sample location AD-SS-AS-01.
